Interference and Direction Analyzer IDA 2

Technical Note TN102

Clock radio disrupts VHF reception

Interference and Direction Analyzer IDA 2 even nails down small interferers

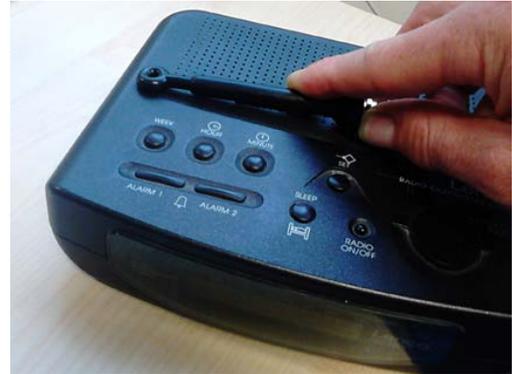
The actual cause turns out to be the defective phase locked loop (PLL) in the VHF receiver of the clock radio, which sweeps through a wide frequency range, causing interference in the reception of several radio transmitters in the vicinity. Many clock radios are still used for the clock or alarm function even though the radio receiver is defective and apparently “dead”, so the device can often interfere with other radio services for a long time without being discovered.

Finding does not mean eliminating. The somewhat unconventional solution here: The Narda employees provide the owners with a new clock radio and take the defective one with them to examine as an object of interest – but this time in the screened laboratory, of course.
