Interference and Direction Analyzer IDA 2

Application Note

Continuous GSM interference from intermodulation

IDA 2 can determine the causes

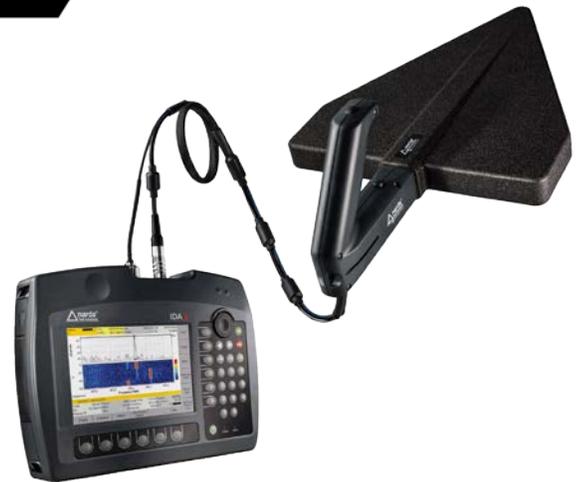
Figure 1: Overview of the GSM 900 and GSM 1800 frequency range. The differences between the many frequencies shown in the spectrum could fall within the GSM 900 uplink range. Example (markers A and B): 1836 MHz downlink – 932 MHz downlink = 904 MHz uplink. The field strengths of over 100 dBµV/m are also enough to produce intermodulation in non-linear structures.

The IM3 products from interaction of GSM 900 downlink channels 1 to 124 (935.2 – 959.8 MHz) occur in the frequency range 910.6 to 984.4 MHz, so they cannot be the cause of the interference in channel 33 = 896.6 MHz. In contrast, the many IM2 products formed by the simple difference between the channel frequencies for GSM 1800 and GSM 900 are possible culprits, so we will focus on the IM2 products in this investigation, which is based on a real situation. Measurements were made 175 m away from a GSM 900/1800 base station at about 60° to the main lobe direction.
