WHO'S ON AIR? WHO'S INTERFERING?

IDA-3106 in action at major events.

IDA-3106 – Facts and figures

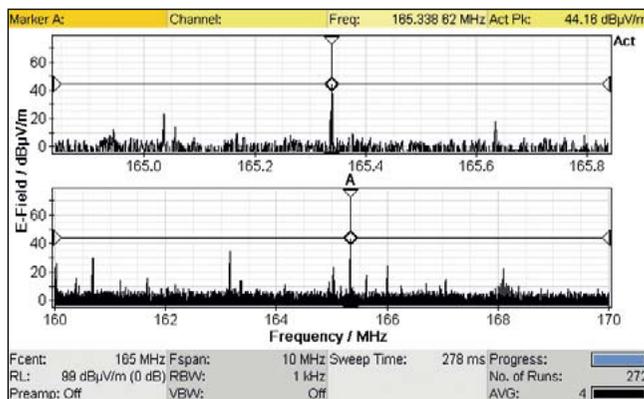
An initial overview from the control center shows the allocation and several interferers (below). The Magnifier takes a closer look at the area around the Marker (above).

The first measurement from 160 to 170 MHz from the control center covers a somewhat wider range than the emergency services radio. The values can easily be read off from the IDA, despite the bright sunshine, thanks to the good screen resolution and high contrast display. The communications channel that needs to be protected is focused on with the

marker using the *Highest Peak* function. A further key press on *Magnifier* activates this function and shows a 10 % section of the entire measured frequency range in the *Magnification low* setting; the *Magnification high* setting would show 2 % of the range. The center frequency of the enlarged spectrum corresponds to the marker position in the full spectrum, which is the center frequency of the affected channel. It quickly becomes apparent that the interference is wideband, most likely caused by some kind of switching. This initial analysis takes just a few minutes.

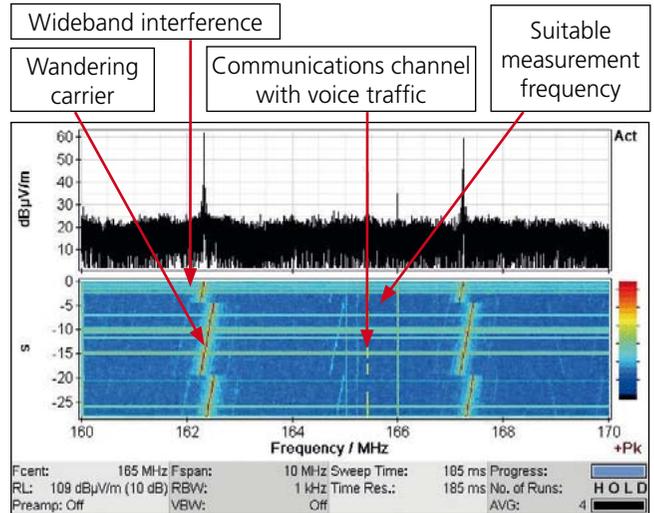
Combined display of spectrum and spectrogram

There first needs to be a check to see if there is any other interference. The IDA in *Spectrum* mode shows all the present activity together by means of FFT analysis. The *Spectrogram* setting additionally shows the correlation between frequency, time, and amplitude, which is very useful. The IDA gives even more information by parallel recording of the results from all three detectors – +Peak, RMS, and –Peak – regardless of the detector type chosen for displaying the spectrogram. Each one can be recalled for evaluation by pressing a button. In the example here, the communications channel can be seen, along with an unstable continuous carrier (wandering signal) and a wideband interferer that covers the entire measured spectrum and occurs every five seconds or so, which is obviously the source of the interference problem.

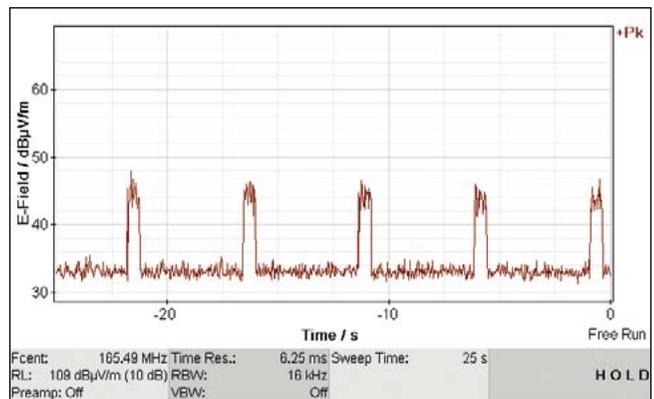
Scope Mode shows the amplitude versus time of the interfering signal

A lot of interference varies in intensity considerably during a burst. This can lead to false bearings. Scope mode with its resolution of down to 32 ns does not just allow a look inside the timeslots of a digital signal. In this case, it shows a relatively constant interference characteristic. The measurement with 16 kHz RBW gives an interference level of 40 dBµV/m. If this is converted to the 120 kHz bandwidth more commonly used in EMC measurements, the result is almost 60 dBµV/m. Such interference values are clearly intolerable

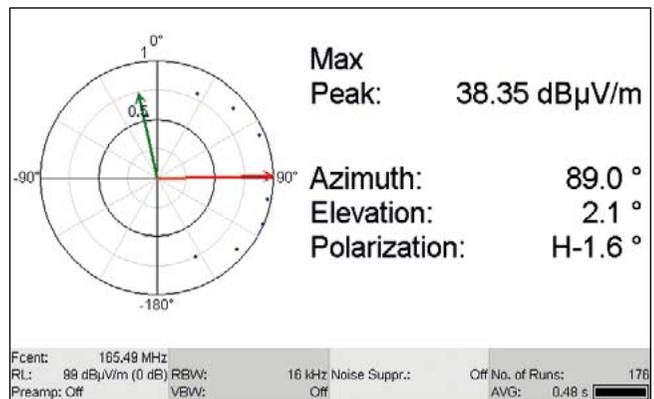
Bearing diagram from seven separate hand-picked measurements

A special feature of the IDA is the Horizontal Scan for transient or intermittent signals: In *Direction Finding* mode this scan can be *Continuous* or *Discrete*, and there is also a *Discrete with Max Hold* setting. With this setting it is also possible to localize pulsed and cyclic or sporadic signals. To do this, the antenna is first positioned in one direction until the interference occurs. The instrument determines the maximum value, which can be added to the scan by pressing a button. This allows individual plausibility testing, as it is possible to select which measurement values are to be added to the diagram. This procedure is repeated for several different directions. As an example,

the antenna could be turned round by about 30° to wait for the interference burst again. The points in the polar diagram correspond to the results obtained in this way. The IDA supplements these points with intermediate values determined using special algorithms, so that a complete polar diagram that also shows any side lobes caused by reflections is produced. The IDA automatically determines the main angle of incidence. At the rate at which the interference is occurring, the IDA takes less than a minute to determine the direction, which points towards the hotel opposite.

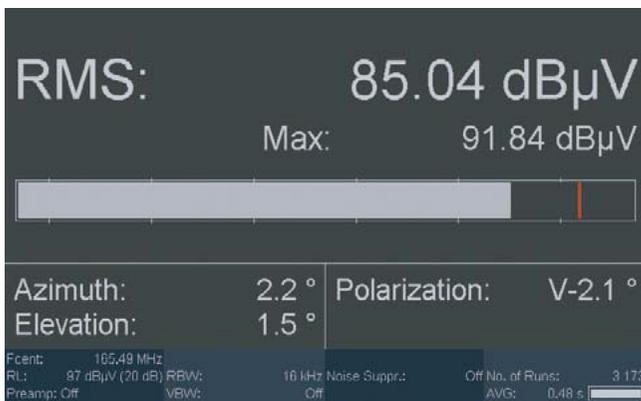
The bar graph and the Tone Search feature help narrow down the last few meters. The Night setting allows dazzle free viewing of the display even in the dark.

Now the search is focused on the last few meters. The IDA is switched to *Tone Search* to determine the direction by means of the tone pitch and the length of a bar graph. After checking with reception, the concierge leads the way to the hotel cellars, where the field strength of the interference increases significantly. The IDA display can be simply switched to the *Night* setting so that the bar graph can be viewed without glare even in the dimly lit rooms. The highest field strength is measured in front of the door to the building services room. Investigations here reveal a defective control board with a sparking relay. The equipment is temporarily taken out of service and the relay is replaced later. This clears the interference and restores secure communications. The event can go ahead as planned.
